Pipeline

September 2014 Issue

HDPE Pipe Experts to the Rescue - Weld County Water Service Restored

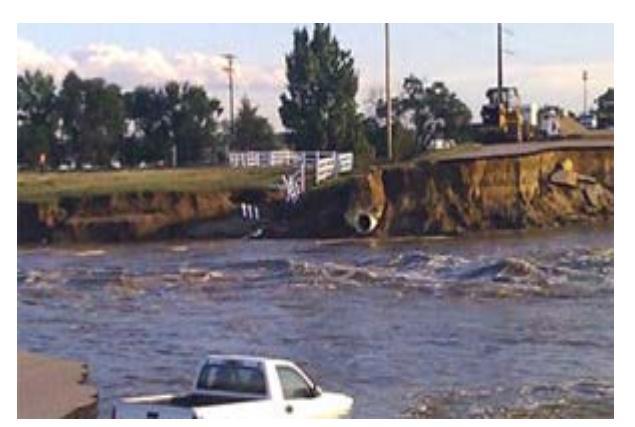
The velocity and volume of water combined to blow a 500' gap in a 36" ductile iron treated water line. WL Plastics and High Country Fusion supplied pipe and fittings within 28 hours of "the call."

Reese then had to contend with the fittings. Knowing he needed fabricated fittings to make the large diameter angles, Reese called High Country Fusion, a specialized polyethylene fabricator in the northwest. High Country had what Reese needed so they loaded "everything we thought Reese would need" onto a flatbed and had it down there by Saturday evening," said David Hanks from High Country. The fittings and valves made it to Keane 28 hours after the call.

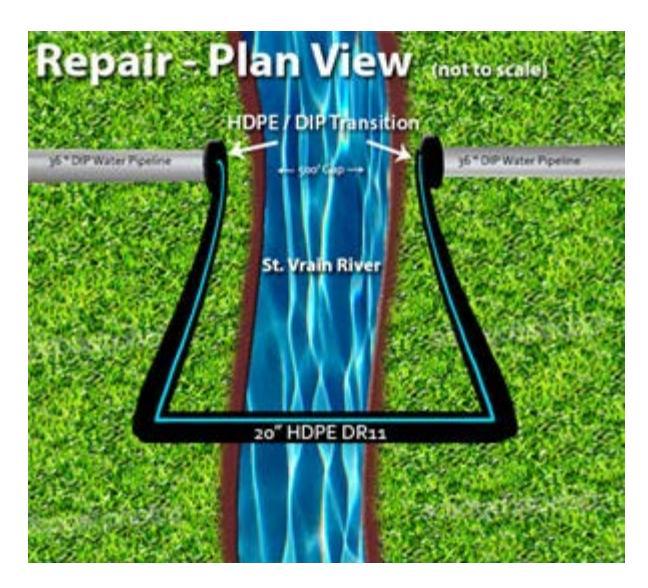
The HDPE pipe was run along the bank on both sides fused together and then draped over the raging river 300 yards north of the break with only the support of the bank. It was braced, but it was literally hung from the bank and draped over the St. Vrain. Once the 2600 feet of pipe was fused it carried the water at its 250 psi from one side of the river, over the river and then back down the other bank. As you can see from the illustration, the line had to head up river to get to the narrow point for the crossing.

Fabricated 90's and 45's were used to change direction on the bypass line. High Country had also sent fabricated 36 x 20" tees to the site. "The tee was great because it changed the direction of the flow and it reduced the diameter to the pipe size available," said Reese. "We did not need a reducer because we had the tee." So on either end of the ductile iron line, a 36" x 20" DIP Tee was installed. The 36" open end was plugged and a butterfly valve was installed. An HDPE MJ adapter was then connected to the butterfly valve. The pipe was then butt fused to the MJ. All told it took a week to fuse the pipe and get it operational.

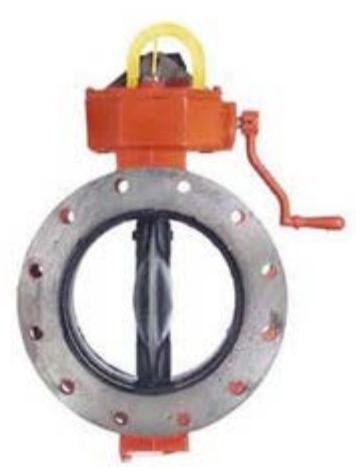
A butterfly valve, similar to this one was attached to an MJ adapter at the point where the HDPE connected to the Ductile iron pipe. Image courtesy of Mueller Company

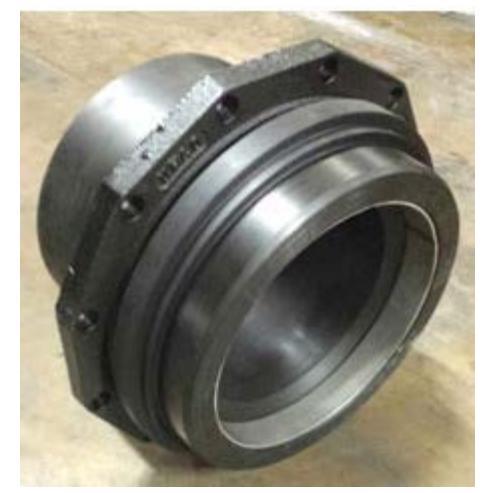
An MJ adapter (mechanical joint) is a common HDPE fitting that permits connection between HDPE and ductile iron. Image courtesy GF-CP.
